Service Note

98-005 Rev B 2 May, 2007

TROUBLESHOOTING OLD STYLE O3 GENERATORS

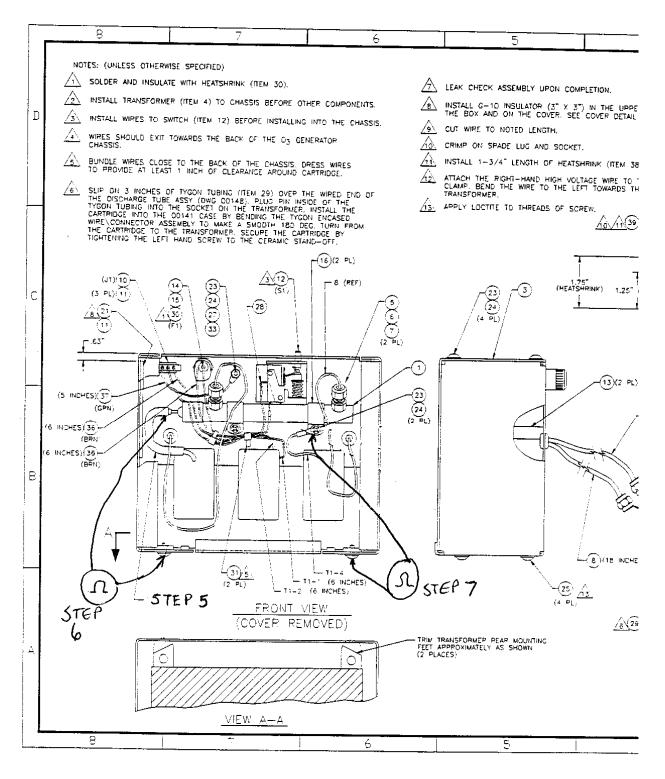
NOTE: For the following steps, see the attached assembly drawing.

- 5. Disconnect the discharge tube from the transformer wire.
- 6. Measure the resistance between the chassis of the O3 generator and the transformer wire, which you disconnected in step 5.
- 7. Measure the resistance between the chassis of the O3 generator and the discharge tube housing.
- 8. The resistance of either measurement must be 11K Ohms. ± 500 Ohms.
- 9. The difference between the two measurements must be less than 1,000 Ohms.
- 10. If the transformer has passed the above tests, it can be assumed to be good and replacement of the discharge tube assembly should restore operation.
