02-029B
2 May, 2007

INSTALLING DIODE MODIFICATION FOR VALVES IN M300E

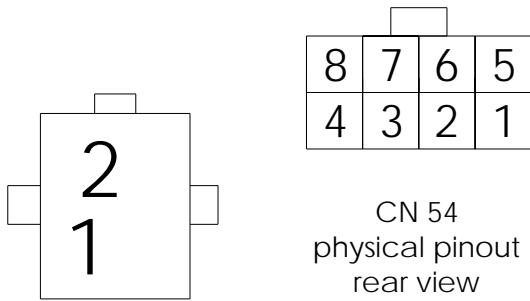
1. Remove power to the analyzer.
2. Remove top cover from the analyzer.
3. Locate the IZS valves in the chassis.
4. Verify that the wiring between the valve driver board and the connectors for each of the valves is proper per the table below. Please use the illustrations below to identify the proper pin number.

5. For each valve you will have to follow the cable from the valve to the connector. In each case you must separate the two halves of the connector and insert the Teledyne API PN#04386-0000 patch cable inline with the valve wires.
6. Install the cover and the analyzer is ready to return to normal operation.
