05-028C

HOW TO TROUBLESHOOT PMT TEMP PROBLEMS IN M100EX/M200EX

05-028 Rev C

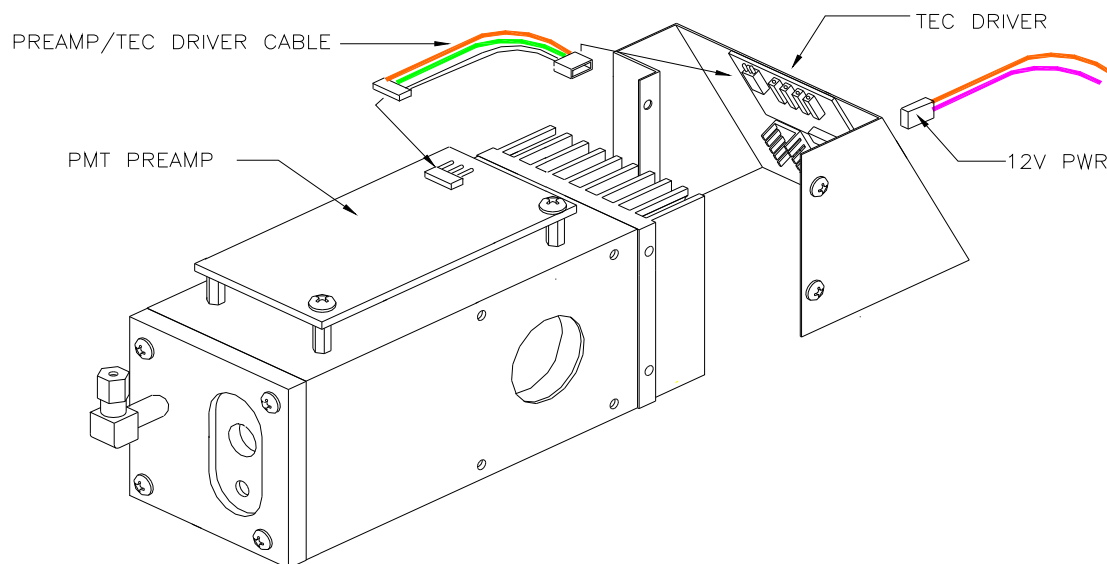
1. Take the cover off. Check if the LED is lit on the TEC control card. If the LED is not lit, check the purple and orange connector on the back of the fan shroud for +12Vdc. Refer to FIGURE 1 for location. If the +12Vdc is good at the connector, go to step 2. If this test fails, measure for +12V on the relay board. Refer to FIGURE 2. Take your meter and measure across the black test point and the orange test point. This should be +12V. Then measure across the purple and the orange test points. This should also be +12V. If not, the 12V power supply will need to be replaced. If the voltage is correct then the problem lies in the cable going to the TEC driver board.

PMT PREAMP/DRIVER BOARD LOCATIONS

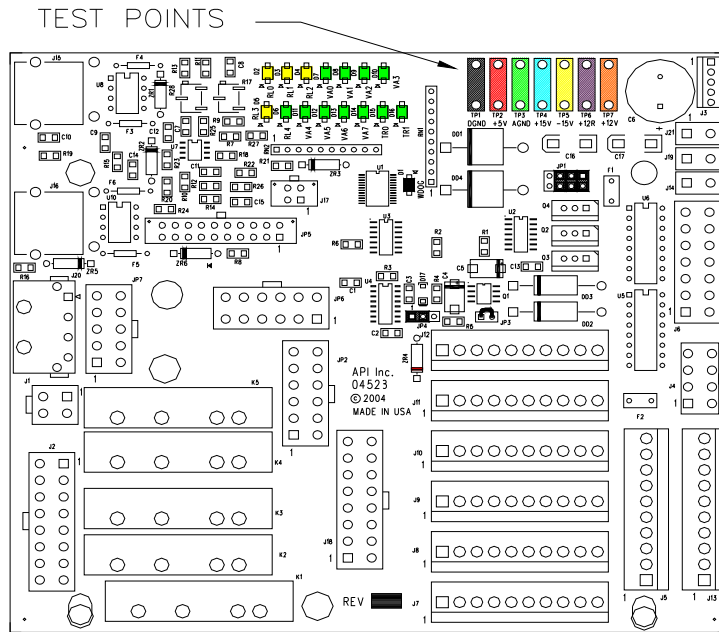
FIGURE 2

RELAY BOARD LAYOUT

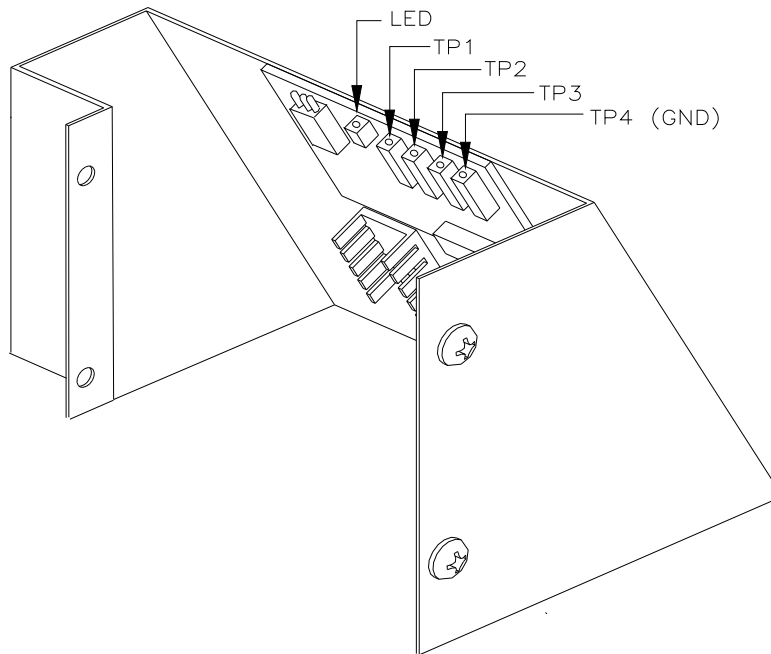
FIGURE 3

4. If the voltage at TP-3 is correct then the cooler drive board or the cooler it-self is bad. Measure the voltage at TP-1 to TP-4 on the TEC driver board. Refer to FIGURE 3. You should have approximately 12.75 ± .5 Vdc. If this voltage is incorrect, replace the TEC driver board. If this voltage is correct, power down the instrument and reconnect the orange, green and white cable back on to the TEC driver board.

TEC DRIVER TEST POINTS
