Service Note

07-024A 7 December 2007

#### CHANGES TO THE TELEDYNE API IN-HOUSE OZONE GENERATOR TEST FIXTURE

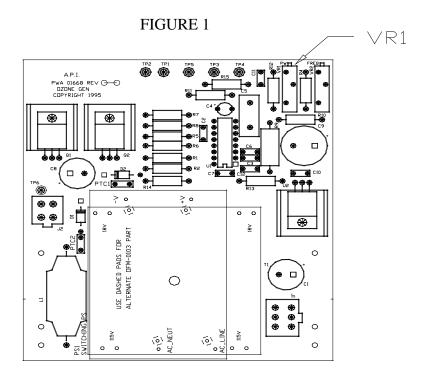
If you are having problems with ozone production in your instrument, please do the following;

Adjust VR1 located on the ozone generator driver board clockwise two (2) full turns. Refer to FIGURE 1 below for the VR1 location. VR1 may also be called PW on some boards.

- If the problem persists, you will need to replace the Ozone Generator Assembly.
- If you have any questions regarding this service note, please contact our customer service department at api-customerservice@teledyne.com.
