<u>12-013</u> 29, October, 2012

TROUBLESHOOTING A DARK CAL / SHUTTER WARNING IN AN SOX ANALYZER

Teledyne API Service Note

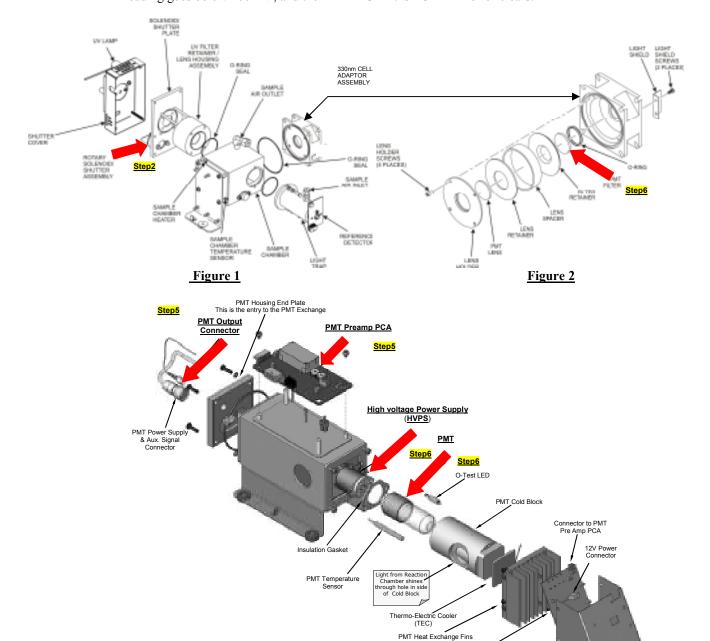
Figure 3

Unscrew the PMT Output Connector/Coax cable from the PMT housing (Figure 3). Observe the PMT_SIGNAL; if the MV reading does not go below 100MV then replace the PMT PRE-AMP board. If the MV reading goes below 100MV proceed to step 6.

6. Your DARK CAL warning is caused by one of three things; a noisy/bad PMT (Figure 3), an unstable HVPS (Figure 3), or a badly degraded 330nm (blue)/360nm (purple) PMT Filter located in the cell adaptor assembly (Figure 2). Replace one of these three parts, one at a time until the PMT_SIGNAL MV reading goes below 100MV, and the DARK CAL / SHUTTER error clears.
