**16-008**

**02 November, 2016**

**T750/T750U ORIENTATION OF THE POWER SUPPLY MODULE FAN**

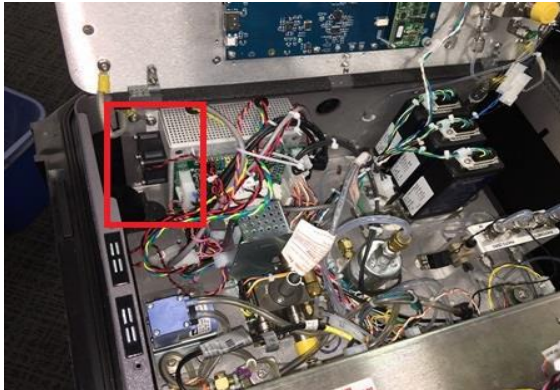
Figure 1 Fan location

2. Open the calibrator to identify the Power Supply Module Fan (see figure 1).

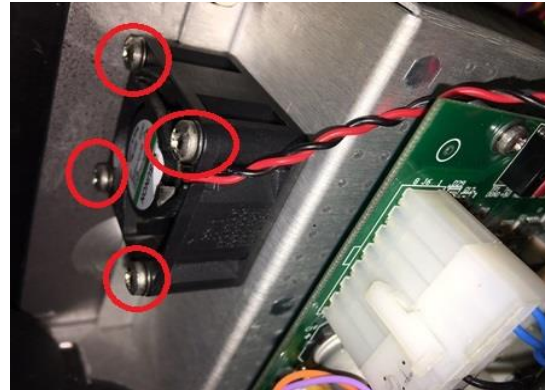
Figure 2 Use ratcheting screwdriver

3. For optimum cooling, the air from the Power Supply Module Fan should be blowing out. The silver sticker in the center of the fan is a good indicator to see if the fan is positioned optimally (see figure 2). If you do not see the silver sticker and don't feel the air blowing out, the fan can be positioned in a better way.

4. Turn power to the calibrator off and remove the power cord, all tubes and connectors from the outside of the calibrator. Remove the 4 screws with the ratcheting offset no.2 Phillips in order to reposition the fan.(see figure 2)

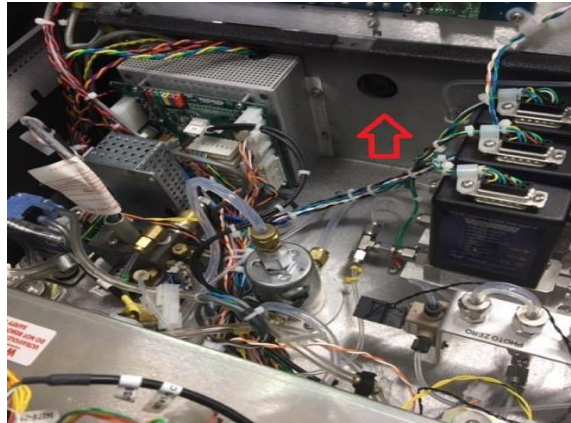
Figure 10 Second person holds case down and makes sure nothing snags

10. One person is needed to lift the calibrator (35lbs) (16 Kg) out of the case (see figure 9). The other person will have to hold the case down and ensure that the case is no longer protruding the circle in the calibrator (figure 10).
