> 10-003A 20-APR-2010

Reseating CPU RAM Chip on A Series Instruments

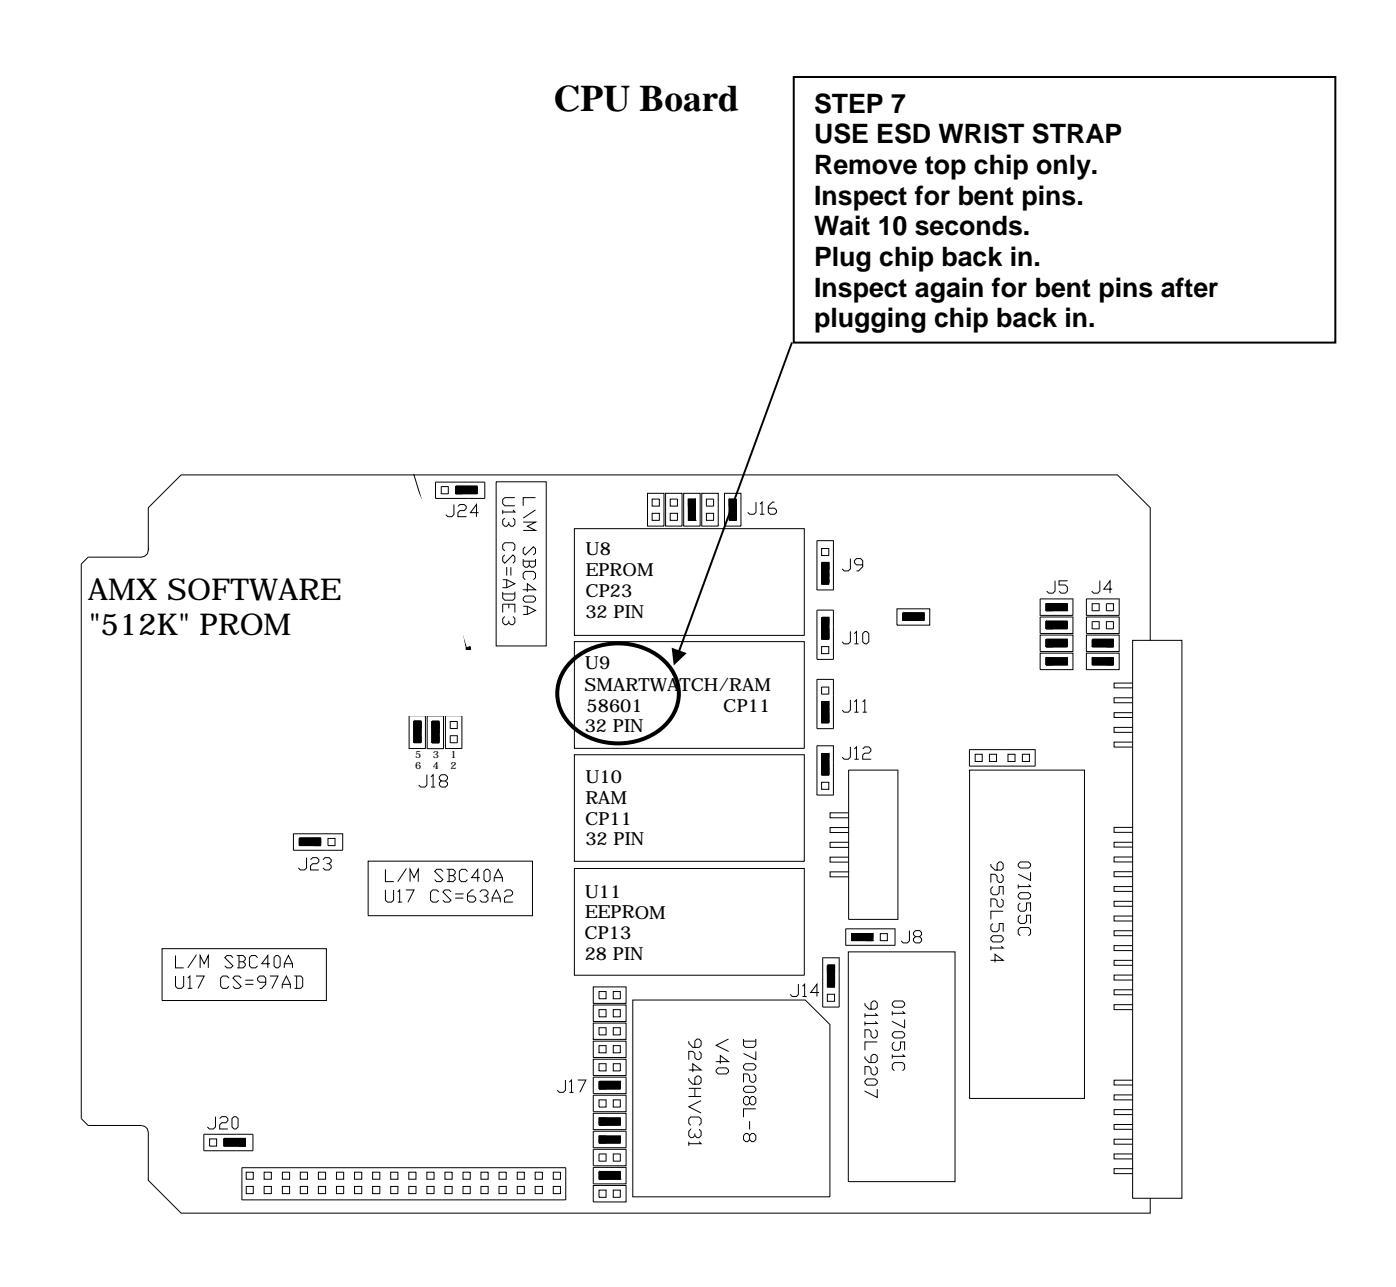
- 6. Refer to Figure 1. (Slot U9) The Dallas Smartwatch battery backup tower IC chip has another IC chip installed into the top of it. Both IC'c together are installed into U9 slot. Some older CPU's have it installed into U10 (slot 10). Erase memory and configuration by removing top chip ONLY (RAM chip) on the Dallas Smartwatch battery backup tower with a chip puller or small screwdriver, inspect for bent pins, wait 10 seconds, and plug chip back in. Inspect again for bent pins after plugging chip back in.
- 7. Re-install the V/F board (with CPU) and associated cables and connectors.
- 8. Re-install power cord, cover and power analyzer on.
- 9. Allow to warm up and re-calibrate.
