Service Note

> <u>22-001</u> <u>31 March, 2022</u>

TROUBLESHOOTING TS1 AND TS2 TOUCHSCREEN ISSUES

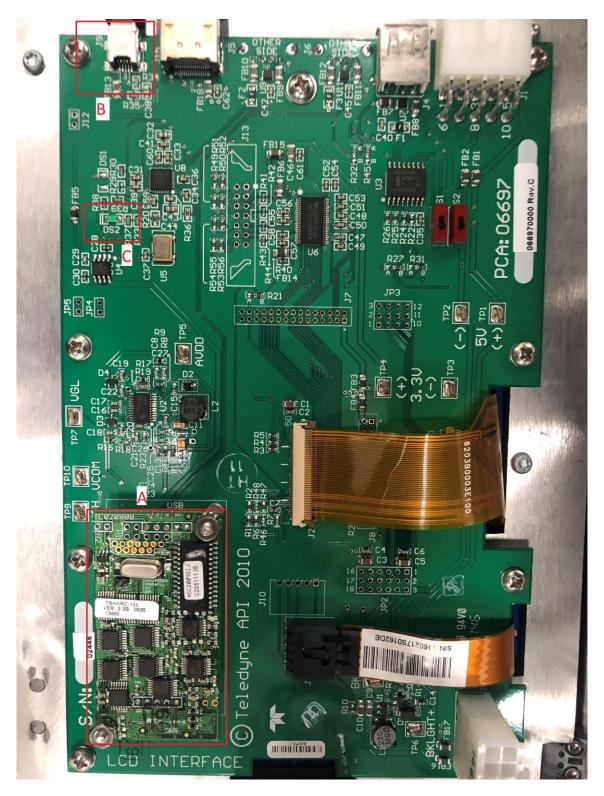
Figure 1

- 2. Lower the front panel and locate the interface PCA behind the display. See figure 1 for a picture of a TS1 interface PCA with touchscreen controller daughter board.

- 3. Check DS2 from **figure 1 part C** to see if this is lit or not. If not, re-seat the micro USB connection at J9 from **figure 1 part B** at the interface PCA, and also at the CPU being careful not to pull on the wires directly. If there is still no light, change the interface PCA.

- 4. If you plug in a USB mouse and get a cursor, see **figure 1 part A** for the TS1 touchscreen controller. If your interface PCA has this daughter board installed, then you have a TS1 display, and this daughter board itself has failed. If you do not have the daughter board on your interface PCA, then you have a TS2 display, and the display itself has failed.
